Structural Damage of Masonry Wall of Palace Type Buildings in Earthquake

Dr Rajan Suwal

ABSTRACT: *In the Gorkha Earthquake 2015 that occurred in Nepal, several buildings were damaged and collapsed in Kathmandu valley. Kathmandu valley (Bhaktapur, Lalitpur and Kathmandu) is well known for its traditional palaces, temples and residential buildings. These palaces were constructed mainly of brick masonry with mud or shukhi mortar, and the next major construction material used was timber. Most of the palaces and buildings of Kathmandu valley are of Malla period(around 300 years old). Other buildings are also more than 100 years old. During Gorkha Earthquake 2015, a number of these types of palaces were damaged and collapsed in the core city and outer area of Bhaktapur, Kathmandu and Lalitpur of Nepal. Photographs of damaged and collapsed of masonry palaces were collected after the earthquake. Different damage types of the palaces are shown. Structural system of these masonry palaces are studied and causes of failure are determined. It is found that the main causes of failure of brick masonry buildings palace type buildings are the lack of proper structural integration systems, decay

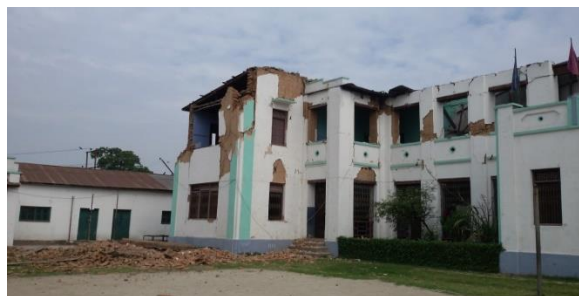
Out of Plane Failure of Building: Most of the old masonry buildings are weak in out of plane action. Mainly, in the top floor, the types of roof used are galvanised iron sheet in timber purlins. Purlins are rigidly connected to the wall. At the top of the wall near roof, there are no any horizontal or inclined timber bands. Due to the improper connections between roof and brick masonry at the top and the lack of connection in both the directions of the masonry wall, out of plane failure might have occurred. This situation is shown in figure 6.1.1. Another side of building failure at the top is of the same nature as shown in figure 6.1.2. All the outer corridor walls got failed and collapsed to the outer side since the top of the corridor columns were not connected properly in the horizontal direction (See figure 6.1.3). Masonry building of Basantapur Durbar (figure 6.1.4) shows out of plane failure of outer wall due to poor connection in between roof and floor level. In Main palace of Basantapur, Gadhi Baithak also fail in vertical crack due to the out of plane failure (figure 6.1.5).

Figure 6.1.1. Out of plane failure
(Shree Padma High School, Darbar Square, Bhaktapur)
Photo source: Rajan Suwal

1. In most of the old masonry buildings of palace type it is observed that out of plane failure due to not proper connection of floors and walls. Walls are more slender which leads to fail.

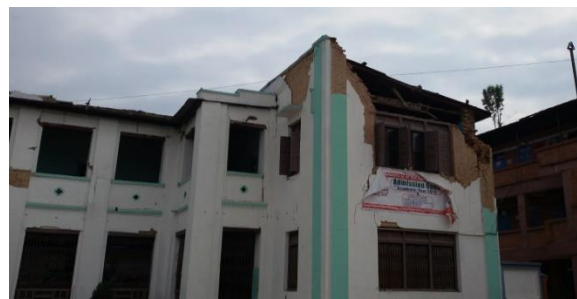
Figure 6.1.2. Out of plane failure
(Shree Padma High School, Darbar Square, Bhaktapur)
Photo source: Rajan Suwal

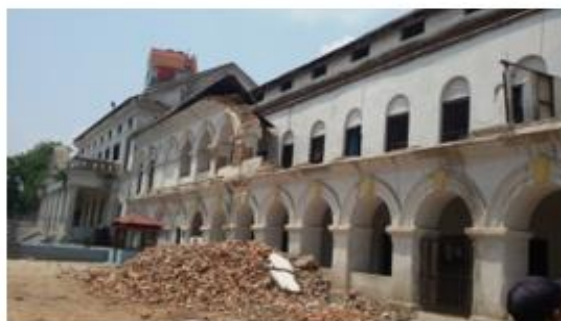
Figure 6.1.3: Out of plane failure
(Darbar High School, Ranipokhari, Kathmandu)
Photo source: Rajan Suwal

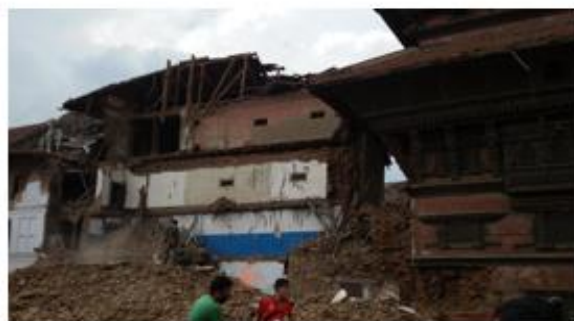
Figure 6.1.4: Out of plane failure
(Basantapur Darbar, Darbar Square, Kathmandu)
Photo source: Rajan Suwal

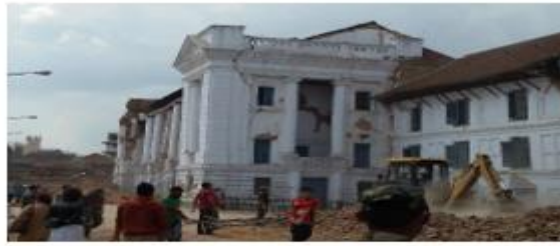
Figure 6.1.5: Out of plane failure
(Gadhi Baithak, Darbar Square, Kathmandu)
Photo source: Rajan Suwal

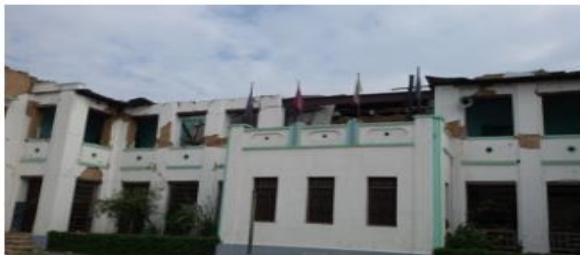
Shear Failure of Building Columns: Brick columns in huge openings are very weak in earthquake. In floors, earthquake load is resisted by thick brick wall. Where there are big openings in brick masonry, horizontal stiffness is drastically reduced which caused failure of brick column which is shown in Figure 6.2.1 and Figure 6.2.2.

Figure 6.2.1: Column failure
(Shree Padma High School, Darbar Square,
Bhaktapur)
Photo source: Rajan Suwal

2. Buildings which have slender masonry columns and were constructed for load bearing or decorative purpose failed due to the not sufficient in lateral stiffness in earthquake load.

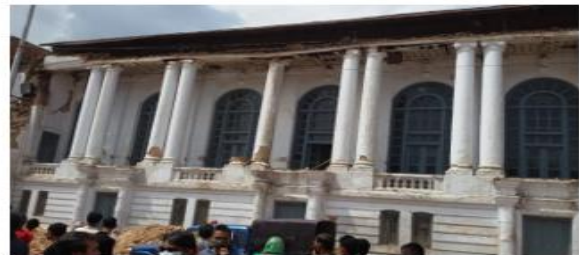
Figure 6.2.2: Column failure
(Gadhi Baithak, Basantapur Darbar Square,
Kathmandu)
Photo source: Rajan Suwal

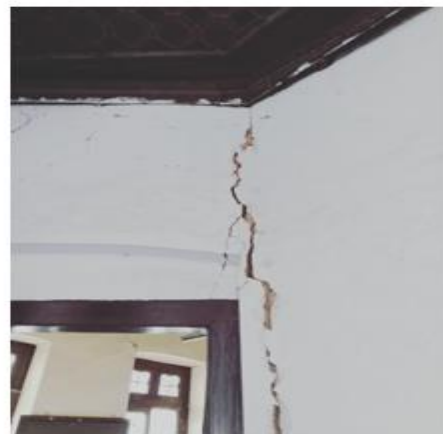
Corner Failure of Building: At the junction of two buildings, a separation in the form of seismic gap is required. Buildings which have different mass and stiffness have different time period and frequency. In the direction of high stiffness, the chances of deflection is less and another building with less stiffness deflects more. Because of this, at the junction of masonry buildings, we can observe failure which is shown in figure 6.3.1. When a building is closely constructed with courtyard at the middle, stiffness of buildings in all the directions will not be the same, and hence, cracks will be developed at the joint of junction partially or in overall height. Crack is developed in the joint of junction of two sides which is shown in figure 6.3.2 in the building of Keshar Mahal, Kathmandu. In this building in the north wing joint it is observed the crack from roof to ground floor.

Figure 6.3.2: Corner failure
(Keshar Mahal, Kathmandu)
Photo source: Rajan Suwal

3. Corner failure of most of the building was occurred due to irregular shape of building. It can be avoided making separation in simple regular figures.

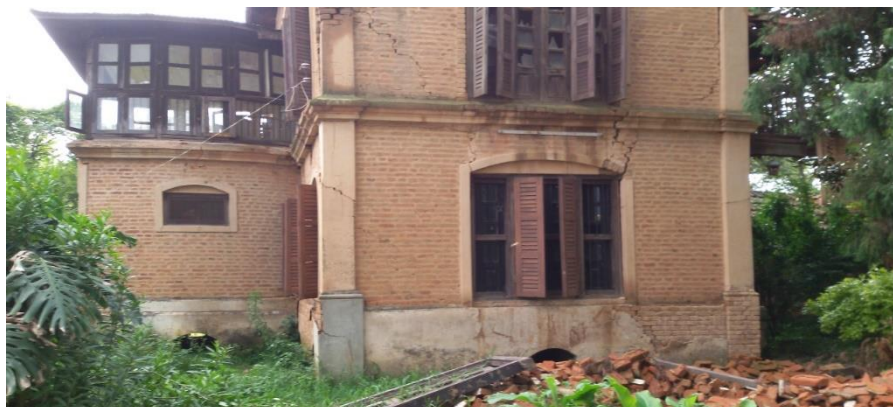
Vertical Shear Failure of Masonry Wall: When window opening width is small with respect to its height and spacing between top and bottom opening is not sufficient, in this case vertical shear failure occurs in masonry structure. Remaining brick work height cannot be resisted the applied shear. This type of failure can be seen in Figure 6.4.1, Figure 6.4.2 and Figure 6.4.3.

Figure 6.4.1: Vertical shear failure over opening
(Judha palace building, Tinchuli, Kathmandu)

4. In same vertical line of high openings make weak in shear of masonry above opening. It would be better to reduce the height of opening and keep higher sill level of windows.

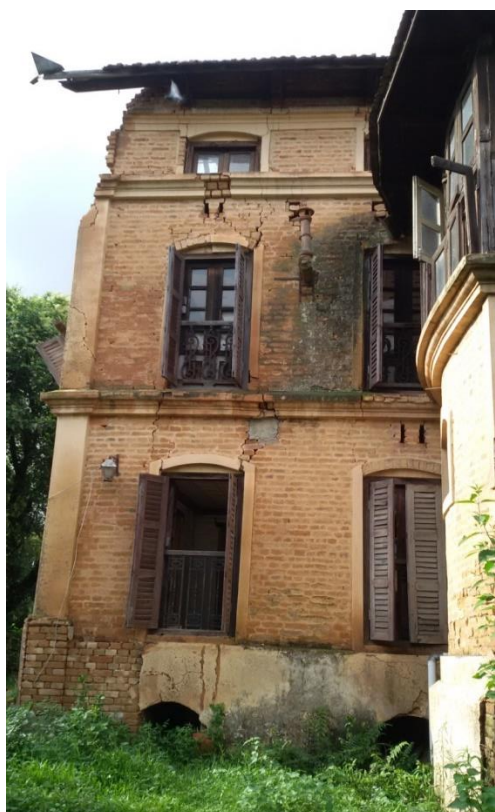
Figure 6.4.2: Vertical shear failure
(Judha building, Tinchuli, Kathmandu)
Photo source: Rajan Suwal

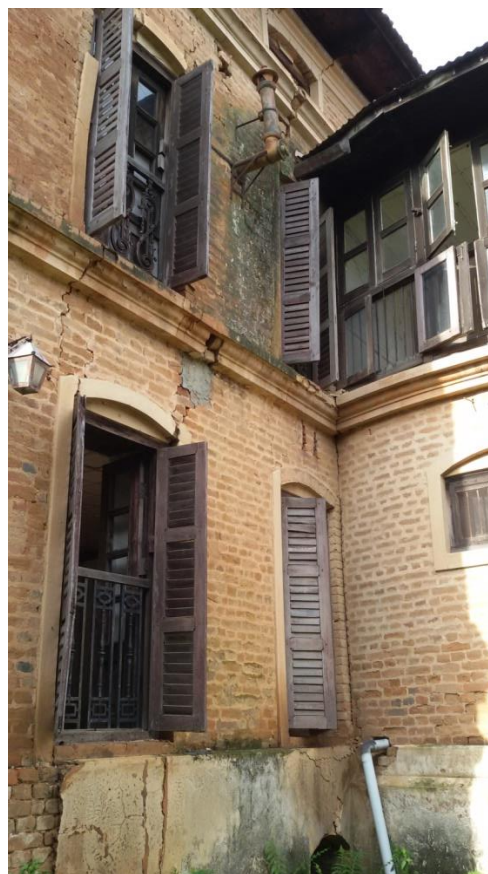
Figure 6.4.3: Other view of vertical shear failure
(Judha building, Tinchuli, Kathmandu)
Photo source: Rajan Suwal

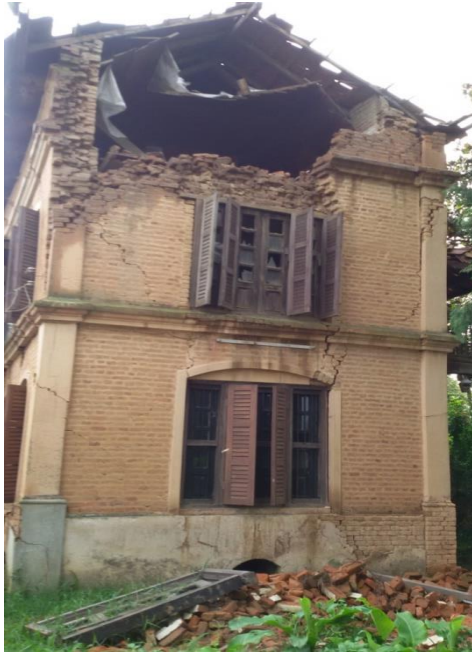
Roof Gable End Wall Failure: In most of the masonry buildings, gable end walls are not connected with main wall properly. Roof rafters and purlins are not connected strong enough. Horizontal and inclined timber bands are not provided. Due to it gable end wall of palace buildings were damaged due to inertia force of this weak part of triangle wall in earthquake. This type of phenomena can be seen in Figure 6.5.1 and Figure 6.5.2.

Figure 6.5.1: Gable end wall of roof failure
(Judha palace building in Tinchuli,
Kathmandu)
Photo source: Rajan Suwal

5. In most of the slender masonry buildings, gable end wall failed due to weak connection between gable wall and rafter frame. There was no timber bandage in inclined part of gable end walls.

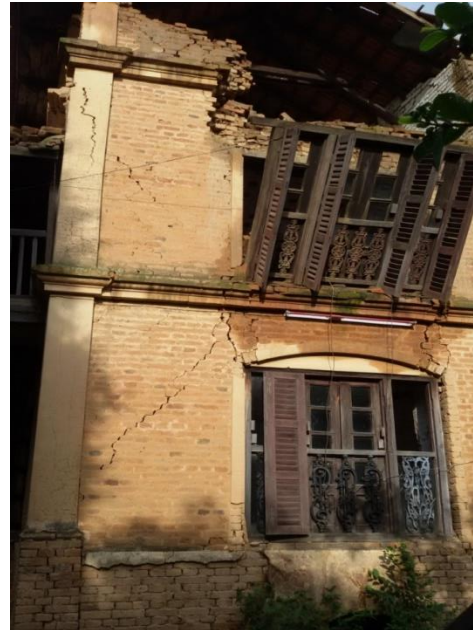
Figure 6.5.2: Gable end wall of roof failure
(Judha palace building in Tinchuli,
Kathmandu)
Photo source: Rajan Suwal

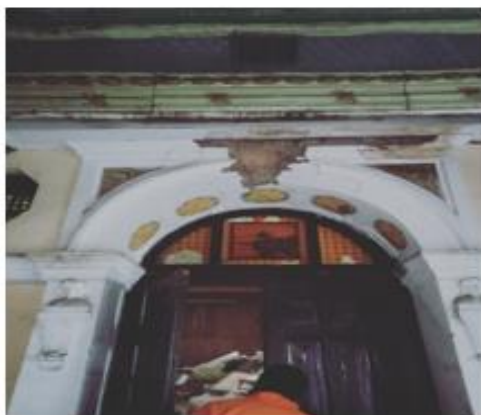
Arch Failure of Masonry Building : Arches are mostly used in old brick masonry palaces and buildings. It is used in the corridors, inside and outside openings. In the time of earthquake, the top area of arches are mainly damaged because it is comparatively weak in shear in perpendicular direction as well as vertical direction. Arches failed at crone or from side. It is shown in figure 6.6.1, figure 6.6.2, figure 6.6.3 and figure 6.6.4.

Figure 6.6.1: Arch failure in main entrance
(Keshar Mahal Palace, Kathmandu)
Photo source: Rajan Suwal

6. Arches of masonry wall in old masonry palace type building seem weak due to less shear resistance capacity. It is required to strengthen with bigger size or stronger material.

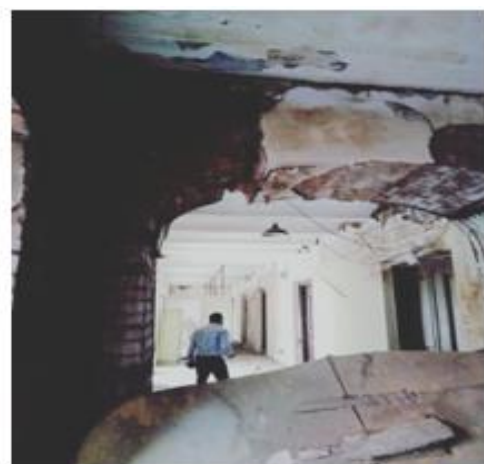
Figure 6.6.2: Arch failure in corridor
(Keshar Mahal Palace, Kathmandu)
Photo source: Rajan Suwal

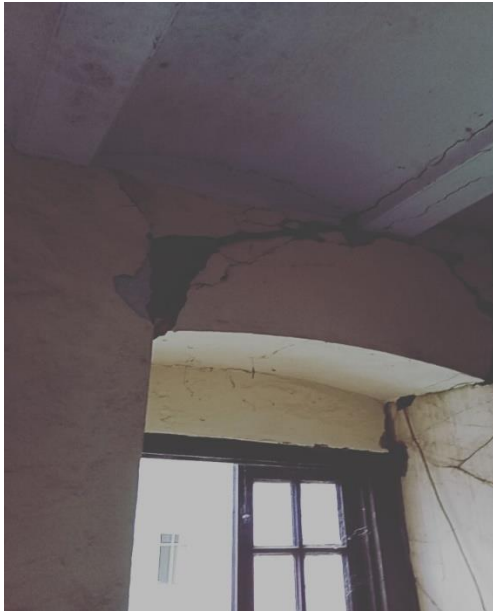
Figure 6.6.3: Arch failure in corridor
(Keshar Mahal Palace, Kathmandu)
Photo source: Rajan Suwal

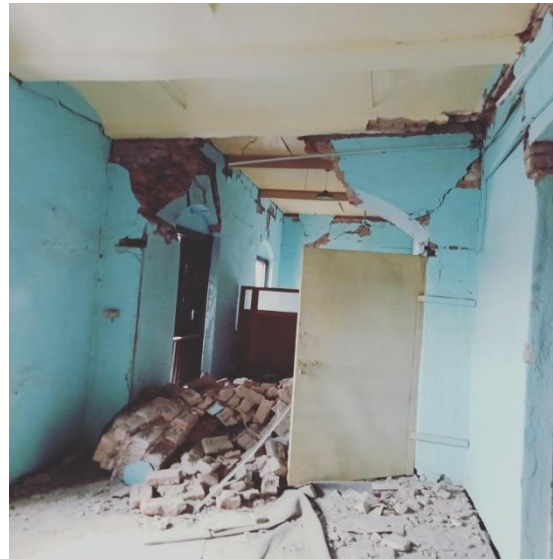
Figure 6.6.4: Arch failure in corridor
(Keshar Mahal Palace, Kathmandu)
Photo source: Rajan Suwal

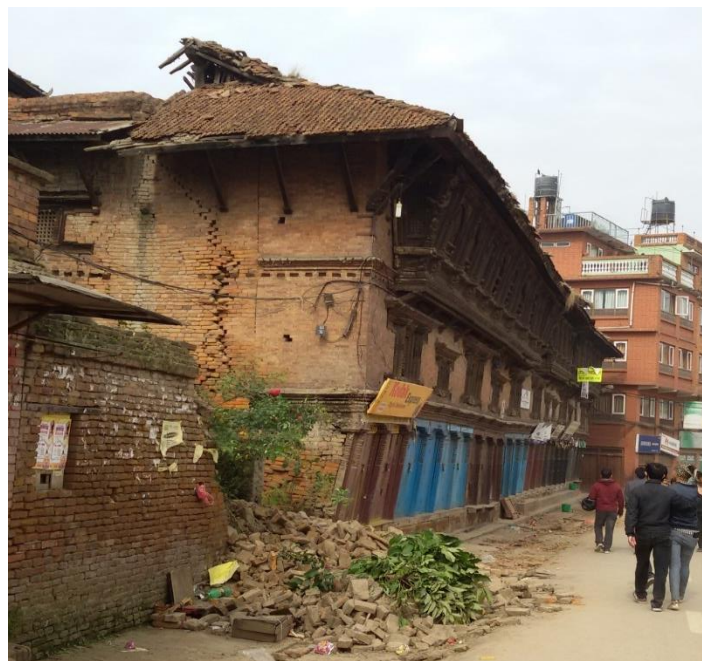
Failure in Joint of Old and New Masonry Wall: In the certain old type of palace buildings front whole face were repaired keeping internal walls untouched. In the process of construction there were no proper bonding between old and new masonry wall therefore it is observed that there is vertical crack in the earthquake. (See figure 6.7.1)

Figure 6.7.1: Vertical crack in masonry wall in old and
new joints of construction
(Khauma, Bhaktapur)
Photo source: Rajan Suwal

7. Continuous joint of old and new masonry building seems weak in earthquake. It is recommended to make joint in different horizontal and vertical level keeping timber joint to make stronger.

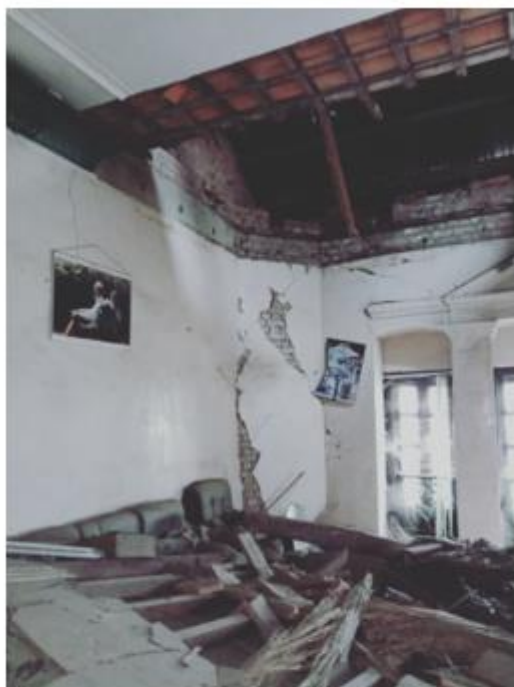
Delamination of roof and walls : In the most of the palace type masonry buildings it can be seen that there is water seepage from the roof. Most of the roofs were made of galvanised iron sheet and some were made of timber with telia bricks. Due to not proper maintenance of roof, delamination in roofs and walls are observed. Wooden part of roof fails due to decay(see figure 6.8.1). In figure 6.8.2 it is seen that wall of top floor of Keshar Darbar is weak condition due to water seepage from roof.

Figure 6.8.1: Falling of roof due to decay of timber
(Keshar Mahal Palace, Kathmandu)
Photo source: Rajan Suwal

8. Old palace type of masonry buildings, it is observed that delamination of building occurs due to water seepage. Because of it timber roof decayed and wall were deteriorated. Therefore it is recommended to do the periodic maintenance of roof and other parts of structures.

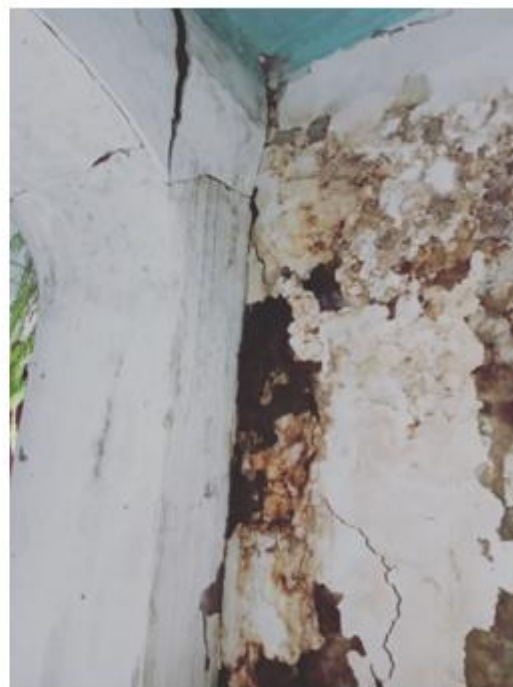
Figure 6.8.2: Deterioration of wall due to water seepage
(Keshar Mahal Palace, Kathmandu)
Photo source: Rajan Suwal
